CITY OF PALACIOS
2022 PAVEMENT INVENTORY

AUGUST 2022

PREPARED BY:
URBAN ENGINEERING
2004 N. COMMERCE STREET
VICTORIA, TX 77901

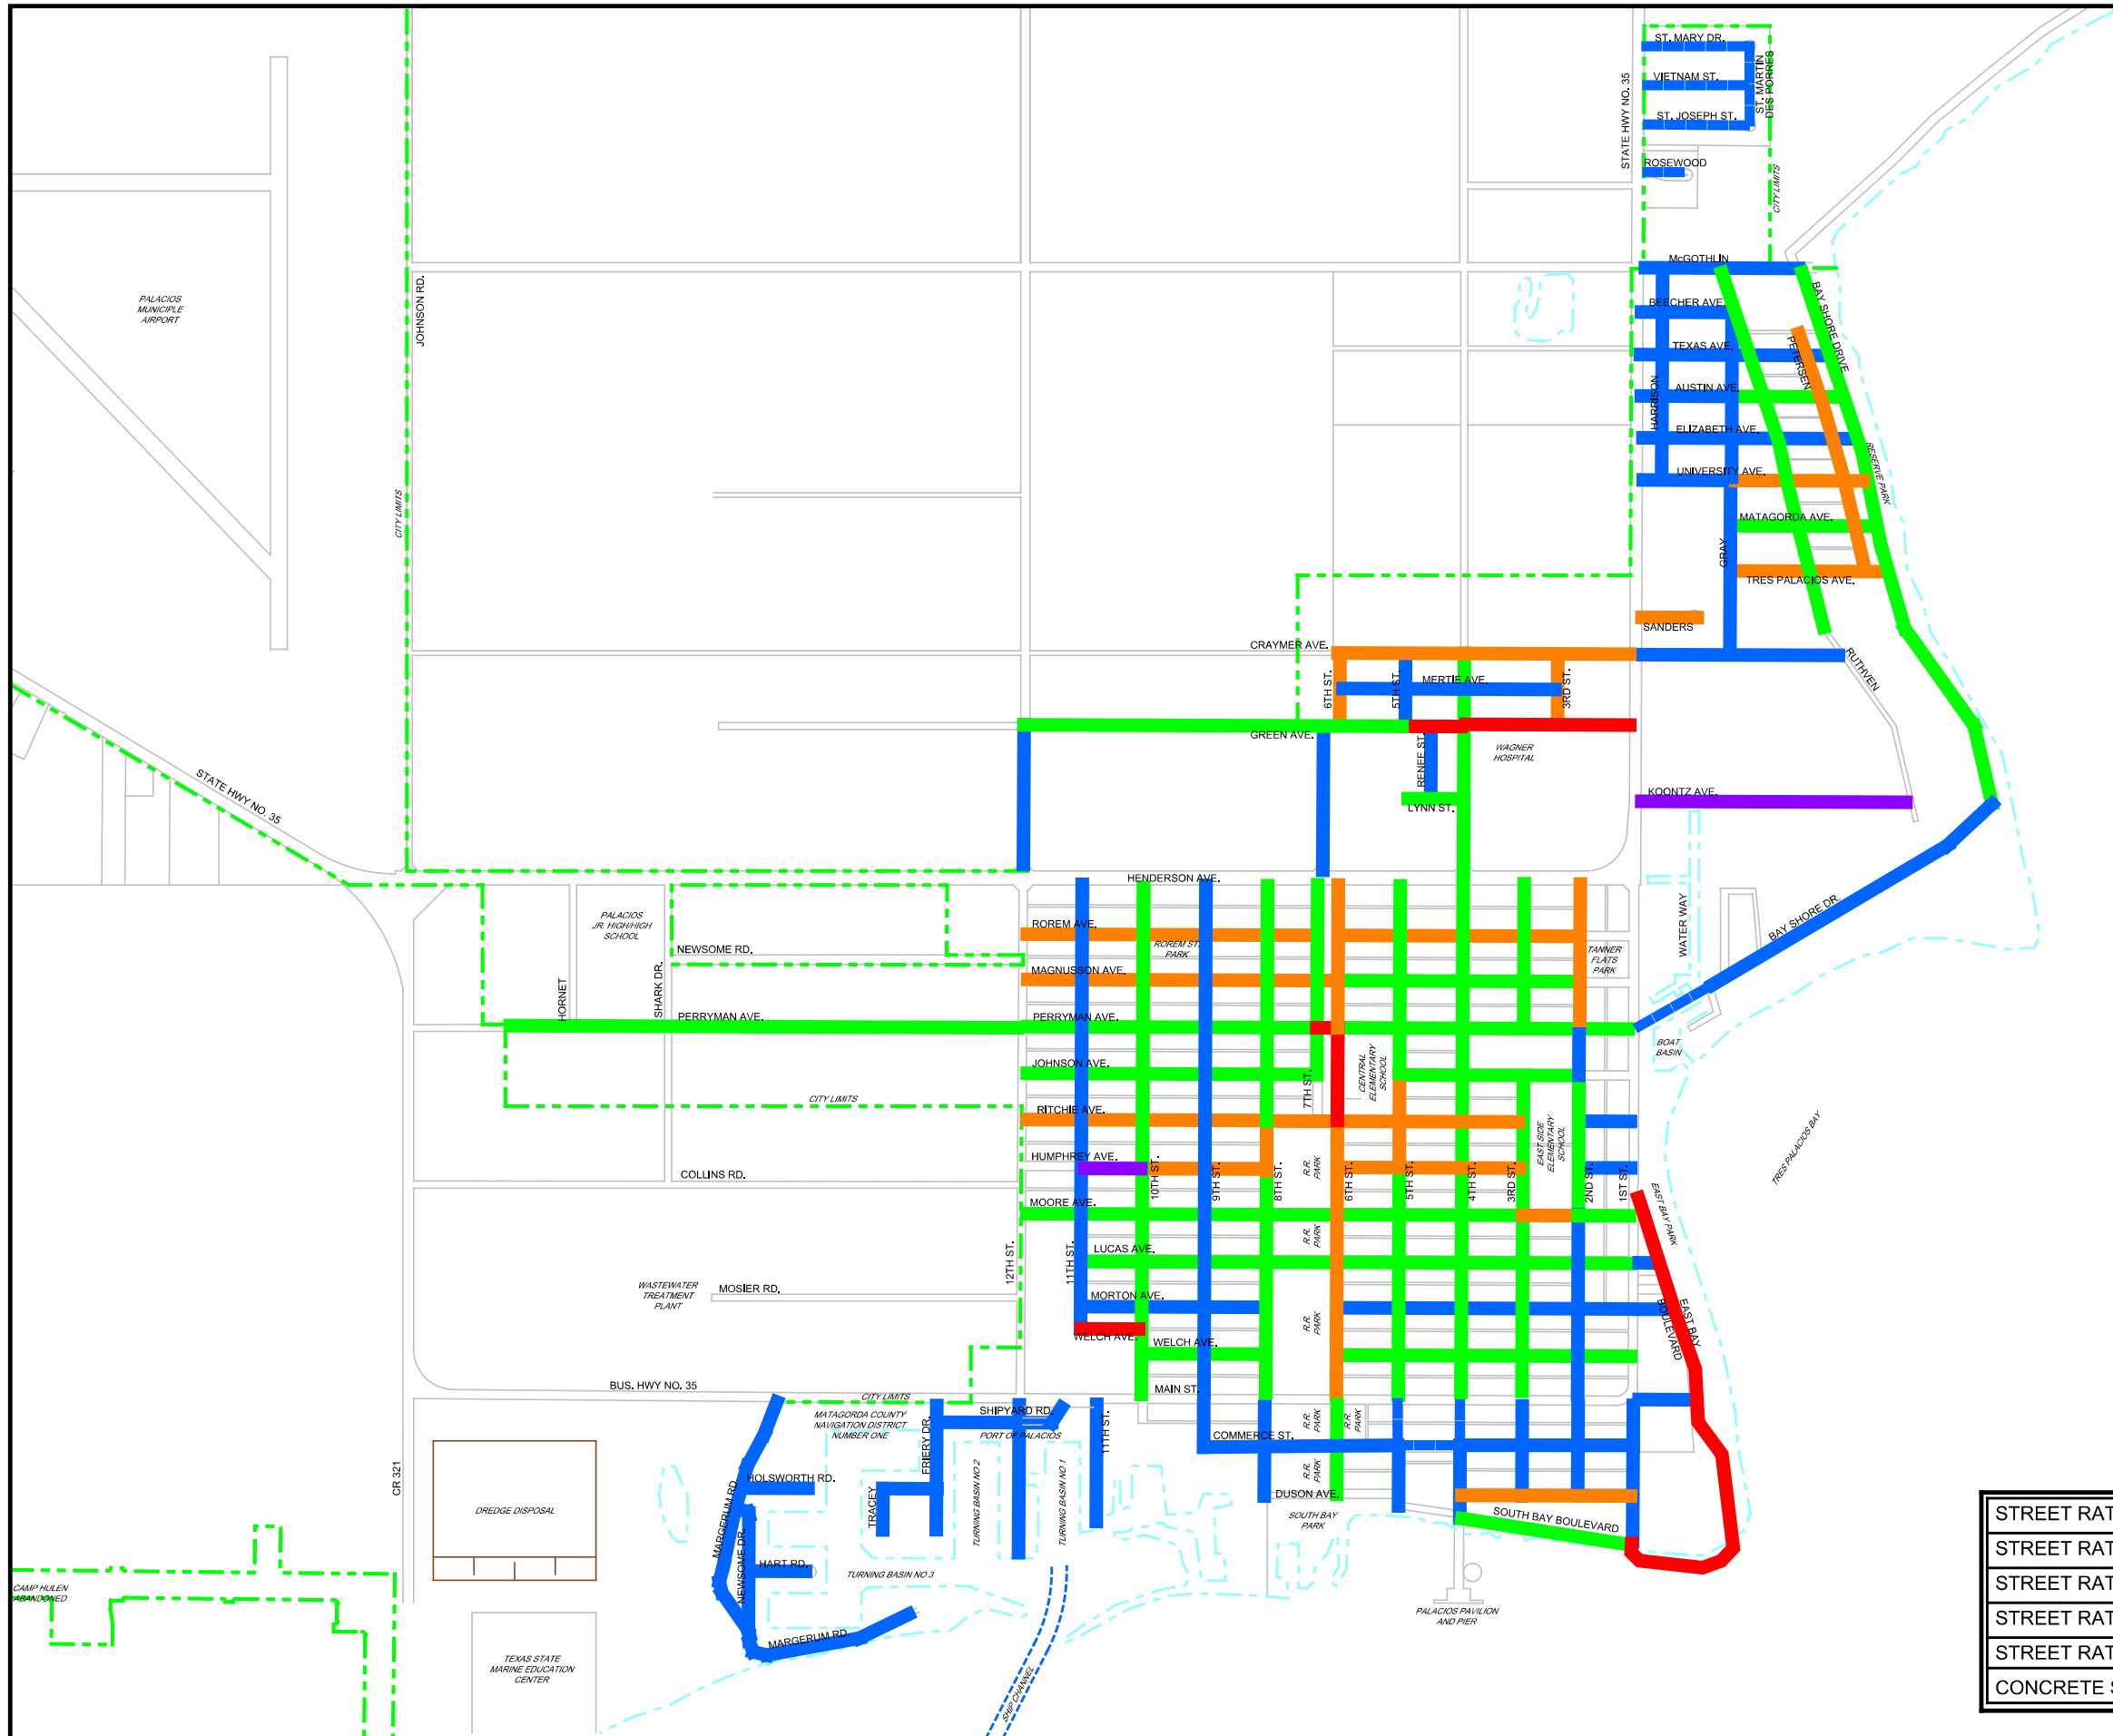
CITY OF PALACIOS STREET INVENTORY

In the map, titled City of Palacios Street Inventory, the ratings which were taken from the street inventory were translated to certain colors corresponding to the condition of the roadway. These ratings were broken down into averages rated between 0 to 100 by values of 20, which 100 being the best and 0 being the worst.

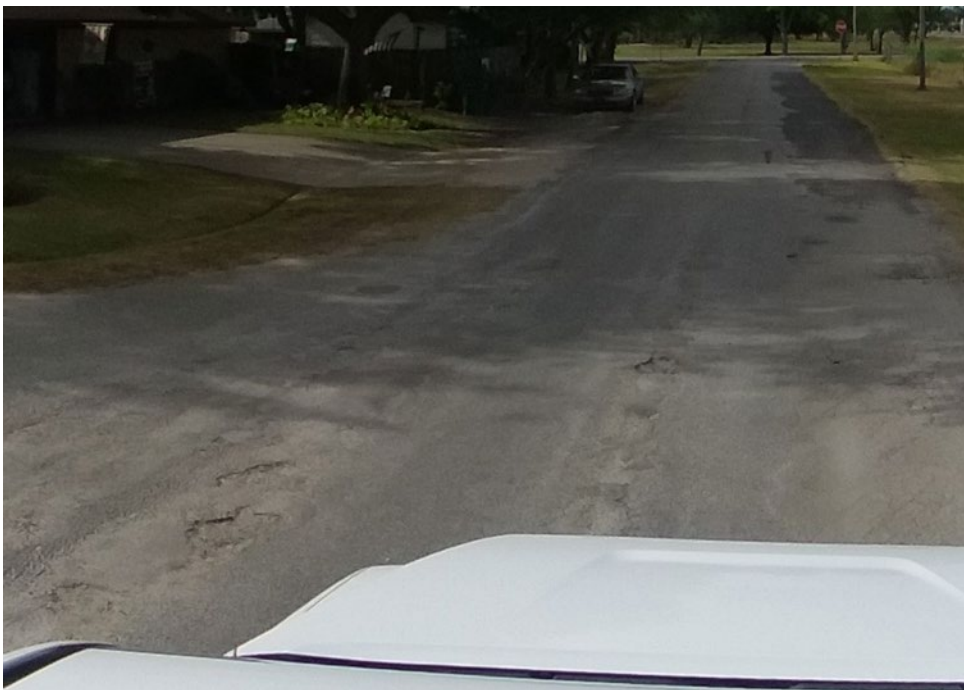
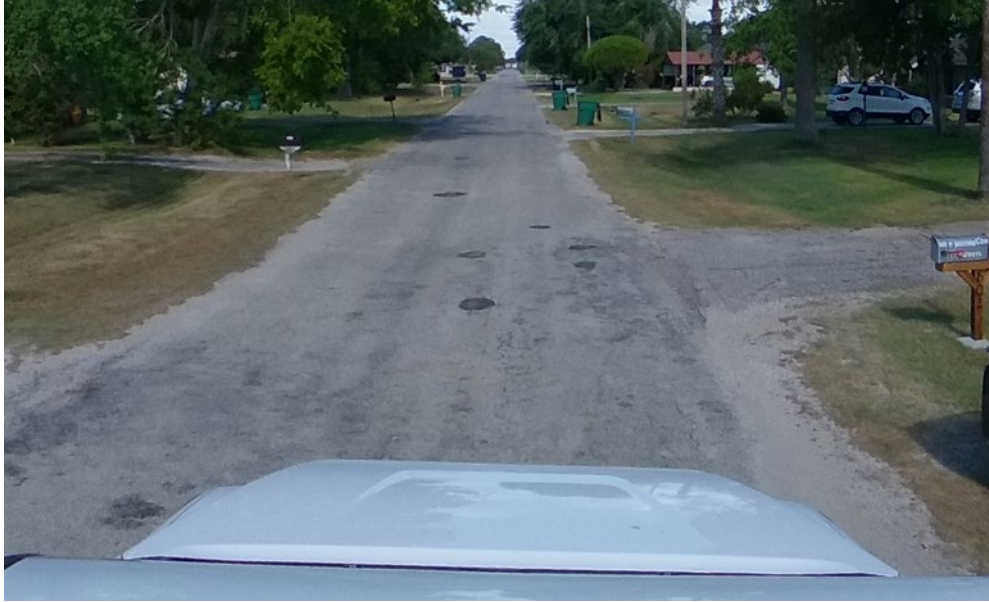
Pot Holes

While most potholes found along the roadways were within the wheel paths, the second most common areas were driveway entrances directly adjacent to the roadway. Many of the driveways within the city limits are gravel or base material. The constant vehicle action on these driveways directly contributes to the wearing of the edges of the roadway where they connect.

Bowl shaped holes caused by weakness in pavement and progressive deterioration.

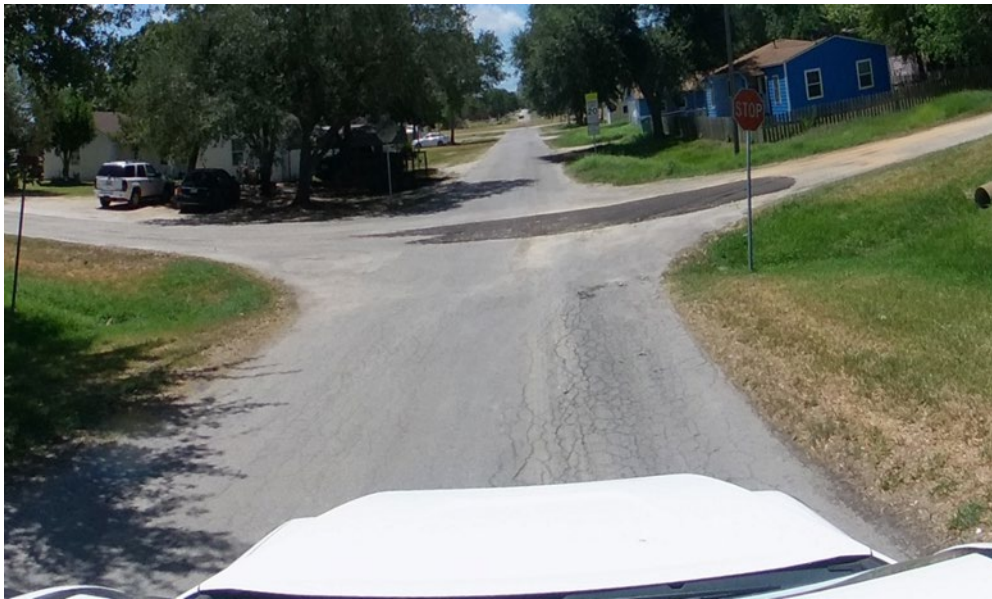
Cracking

The most frequent defect found on roads is cracking, which includes longitudinal and alligator cracking. Longitudinal cracking was observed on most roadways within the city limits of the City of Palacios and was primarily concentrated on the edges of the pavement surface. Alligator cracking was also observed on most roadways and intersection. Unlike the longitudinal cracking, the alligator cracking was not concentrated at any specific areas and spanned across the pavement surface. Service vehicles, such as waste disposal, delivery trucks, and postal service vehicles, contribute significantly to cracking of the pavement surface because of the additional loading due to their weight and operation on the edges of the pavement to collect waste or deliver goods and mail.

Series of cracks in pavement usually caused by unstable subgrade or movement in the ground.

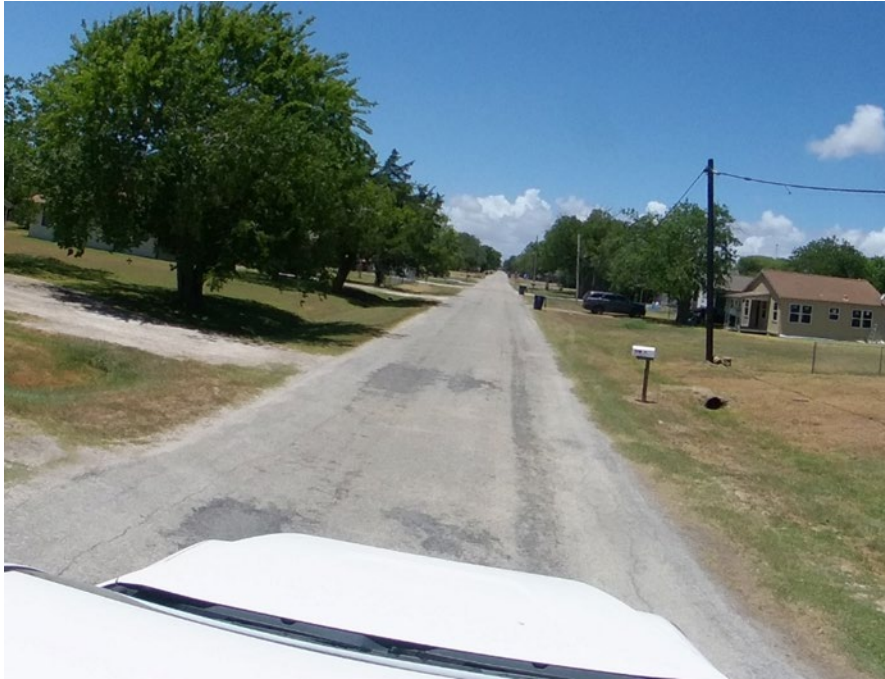
Polished Aggregate/Excess Asphalt

Surfaces that have been worn smooth by traffic or aggregate that is applied in excess.

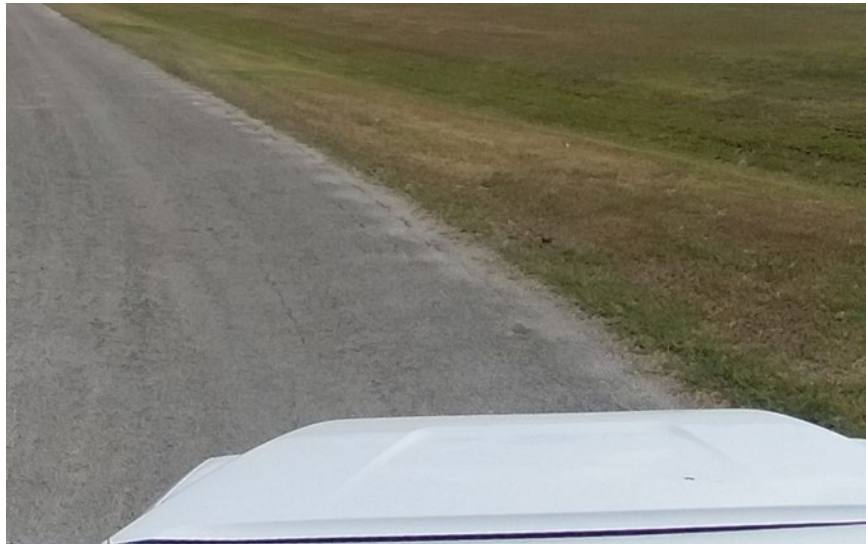
Road surface depressions or movement was observed on many of the streets within the City of Palacios. Rutting is the depression of the pavement surface parallel to the direction of traffic and is typically found in the wheel paths. Shoving and pushing is the lateral displacement of the paving material due to the action of traffic and typically results in the bulging of the surface perpendicular to the direction of traffic. These types of surface movement significantly reduce the ride quality of the streets and resulted in lowered ratings on the roads. Again, these defects were concentrated on the edges of roads.

Depressions in pavement caused by displacement of asphalt and or traffic use.
